# **ALEXA LF Software Update Package 4.2**

**for ALEXA LF cameras (SUP\_AlexaLF\_4.2\_44002)**

## **RELEASE NOTES**

**December 04, 2019**

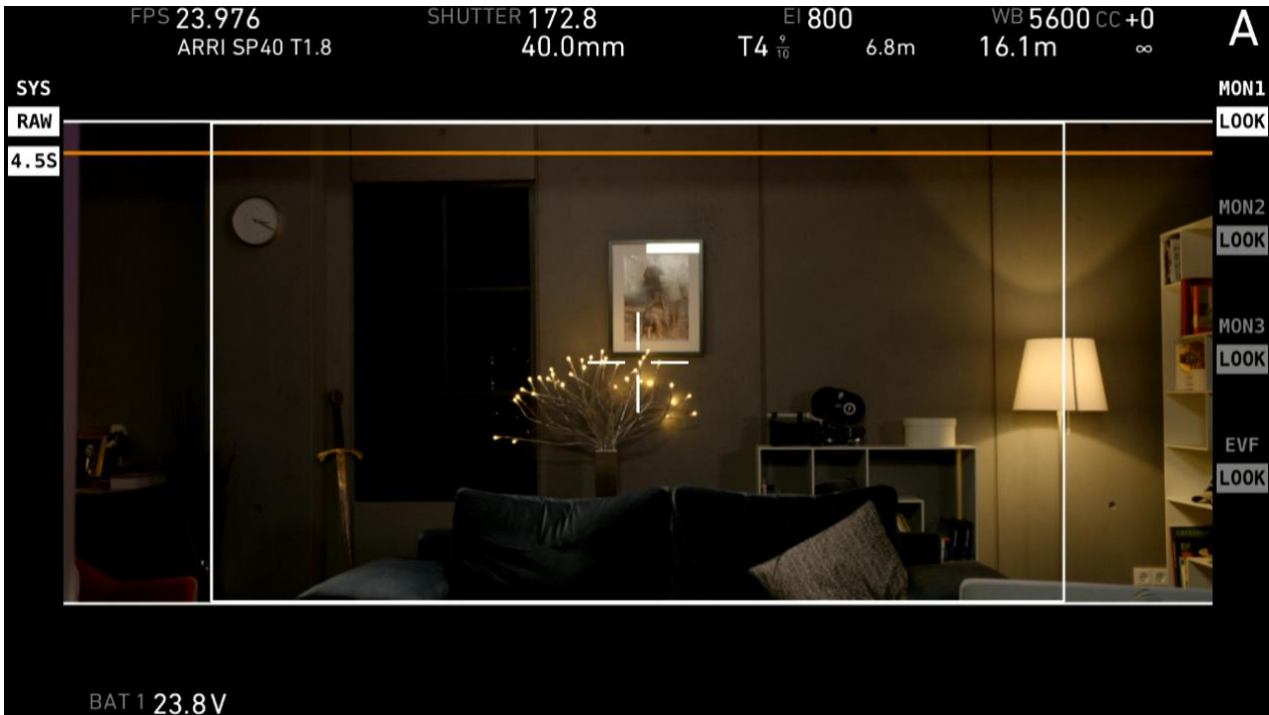
## Orange Line in Frame

A horizontal orange line can appear in the frame where it does not belong (see image above) in the following cases:

- LDS info is turned on while
  - the camera is in LF 2.39:1 sensor mode and
  - an LDS lens is attached and/or LDA is enabled
- LDS info is turned on while
  - anamorphic de-squeeze is on and
  - an LDS lens is attached and/or LDA is enabled

Note 1: Unfortunately, the line comes back after each camera reboot or when any changes to the MON OUT settings are made.

Note 2: The orange line is there on purpose when it appears directly underneath the LDS info, i.e. touching the LDS info area. In that case the orange line indicates that there is image information (that is being recorded) underneath the LDS info. This orange line cannot be removed with the procedure above.

The orange line can be removed with the following procedure (if LDA causes the issue, turn LDA on/off instead of removing the LDS lens):

- Make all the MON OUT settings you need (framelines, center cross, etc.) first. Any change to the MON OUT settings will bring that orange line back
- Remove the lens
- Turn LDS info off. This can be done in MENU > MONITORING > MON OUT <X> > FRAME LINES + STATUS INFO > LDS INFO
- Wait 10 seconds
- Turn LDS info back on
- Re-attach the lens
