WVS Software Update Package 4.3.26

For WVT-1, WVR-1 and HD video transmitter in ALEXA LF and ALEXA SXT W

RELEASE NOTES

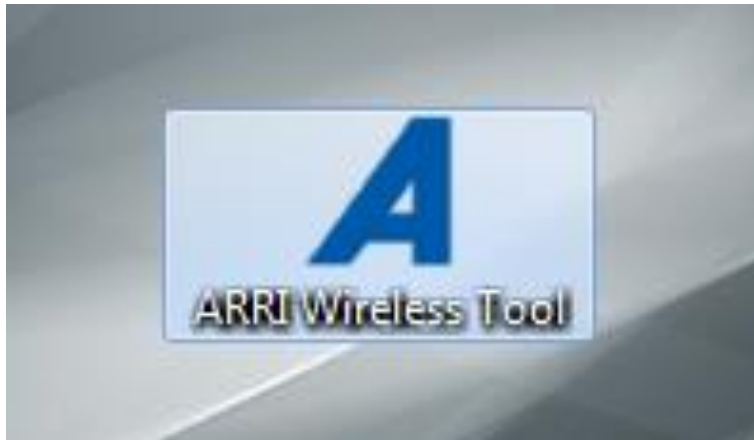
Start the ARRI Wireless Tool software.

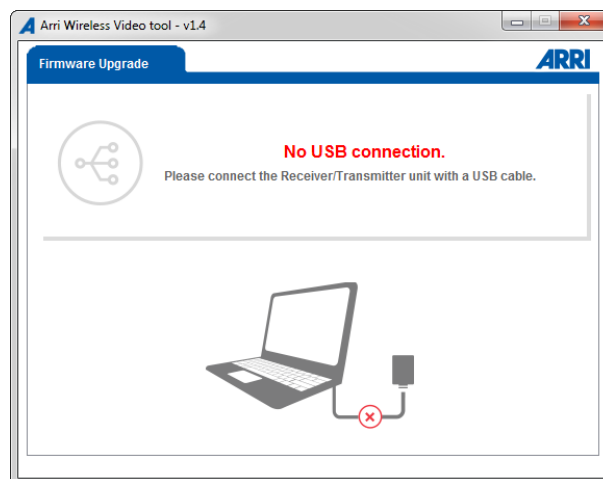
- Until the WVS device is powered, the ARRI Wireless Tool will prompt that no USB connection is available.

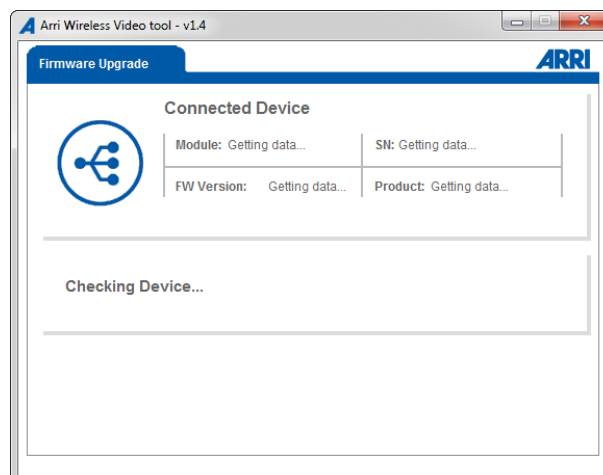
- Power the WVS device using a power supply.
The ARRI Wireless Tool will check for the device and read out its data.

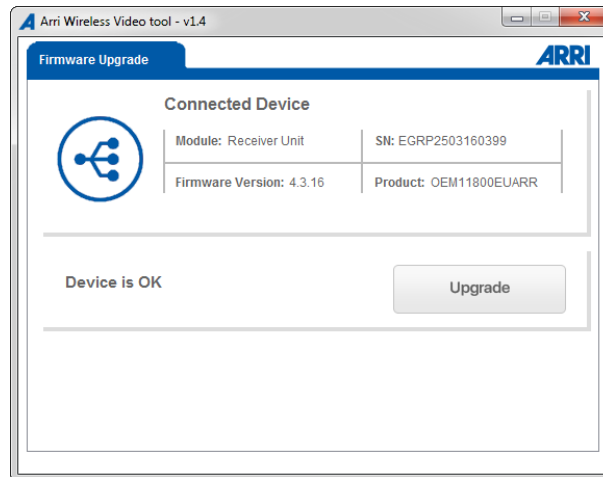
- Once connected, the WVS device data is displayed.

Module: Receiver Unit or Transmitter Unit
 SN: Device serial number
 Firmware Version: Currently installed Firmware Version
 Product: Device product code, includes wireless region identifier

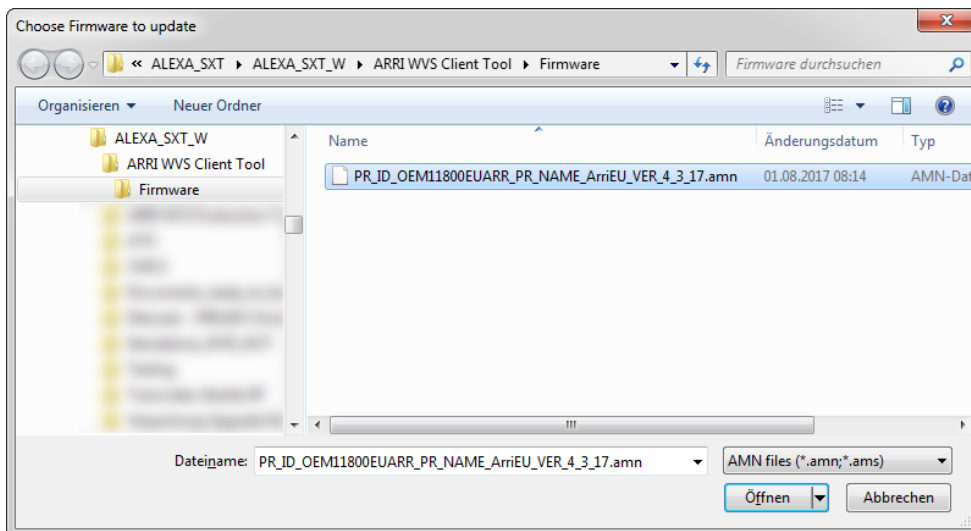
- To upgrade to another firmware version, click the Upgrade button
 In the file system explorer window navigate to the folder containing the firmware update files.
 Make sure to choose the file which includes the same product code in its name as your device (e.g.: OEM11800EUARR). Please always use the latest firmware on all your devices.

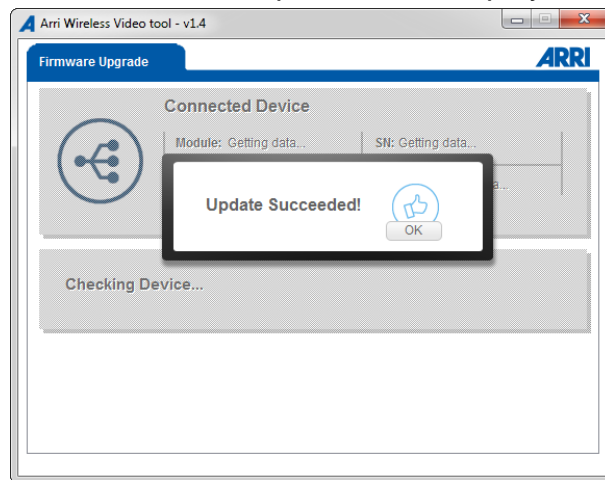
- The upgrade process may take up to five minutes. The device will restart automatically. Once the update is finished, a pop-up will be displayed.
- Click OK to confirm. The device data is updated and displayed.

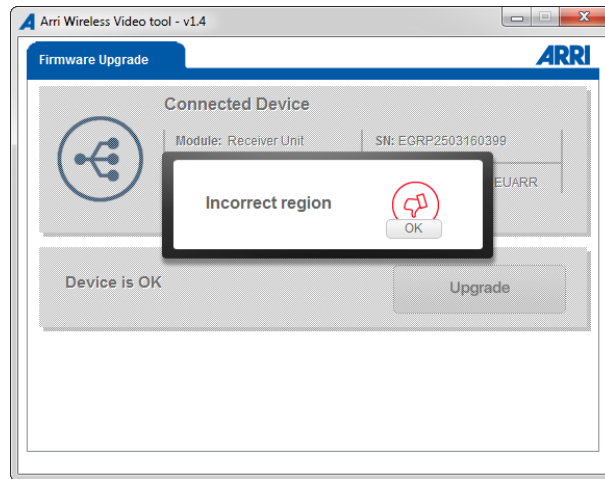
In case the updater states “Incorrect region” please verify that the product code of the firmware update file is correct.

It is not possible to program a firmware with a different region setting. If you need to have the region setting of your device changed, e.g. to match a device with a different product code, please contact your nearest ARRI Service Subsidiary.
