ALEXA 35 ALEXA 35 Live

Software Update Package SUP 4.0.0

RELEASE NOTES

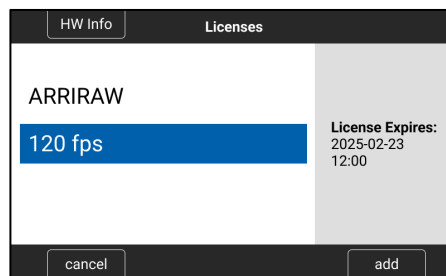
You can check the installed licenses on any ALEXA 35 camera in the camera menu. Temporary licenses display their expiration date in the grey info pane on the right.
